THE  
ECCLESIASTICAL  
ARCHITECTURE  
OF SCOTLAND

FROM THE EARLIEST CHRISTIAN TIMES TO THE  
SEVENTEENTH CENTURY

BY  
DAVID MACGIBBON AND THOMAS ROSS  
AUTHORS OF "THE CASTELLATED AND DOMESTIC ARCHITECTURE OF SCOTLAND"

VOLUME ONE

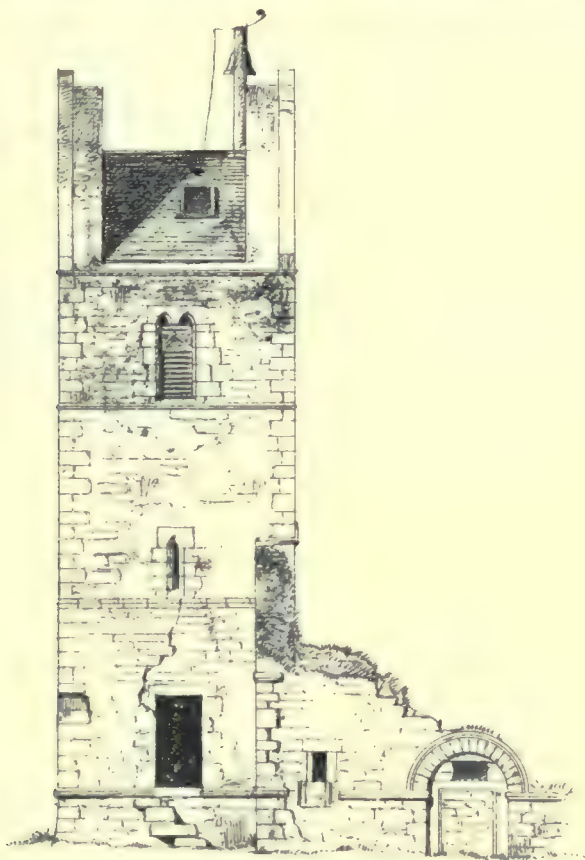
FIG. 435.—Lasswade Church. South Elevation.

double-pointed lights, with central mullion in each face. This story had an enriched cornice, above which rose the east and west gables, each with a small round-headed window. A door had been knocked into the tower on the south side (Fig. 435), which, doubtless, helped to weaken it.

In a portion of the south wall of the church, near the tower, there was preserved an original doorway (see Fig. 435) about 5 feet 6 inches wide. It resembled that to the tower in design, having plain jambs, with a string course forming the imposts, and a plain round arch above, enclosed with a hood moulding. All the above features seem to point to the structure being one of the first half of the thirteenth century.

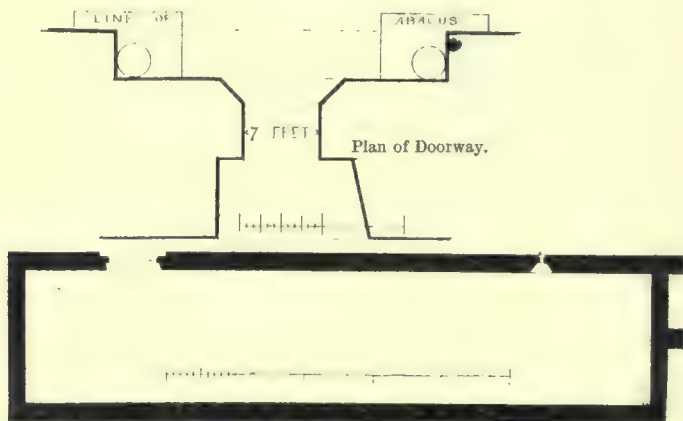
FIG. 437.—Bathgate Church. Plan.

ivy-covered building (Fig. 437), measuring internally about 91 feet 2 inches from east to west by 19 feet 5 inches from north to south, with walls from 3 to 4 feet in thickness. The doorway, which was probably round arched, is almost the only feature of its architecture left. The opening is unusually wide, showing 7 feet of daylight (see Fig. 437), and, judging from its details, the church belonged to the transitional period. The doorway was decorated with shafts placed in square nooks or recesses, with carved capitals having the square abacus, a certain feature of early work. (Fig. 438.) Both inside and outside the walls are so entirely covered either with ivy or tombstones that almost no part of the masonry can be seen; only one small window on the north side, about six inches wide, being partly visible.

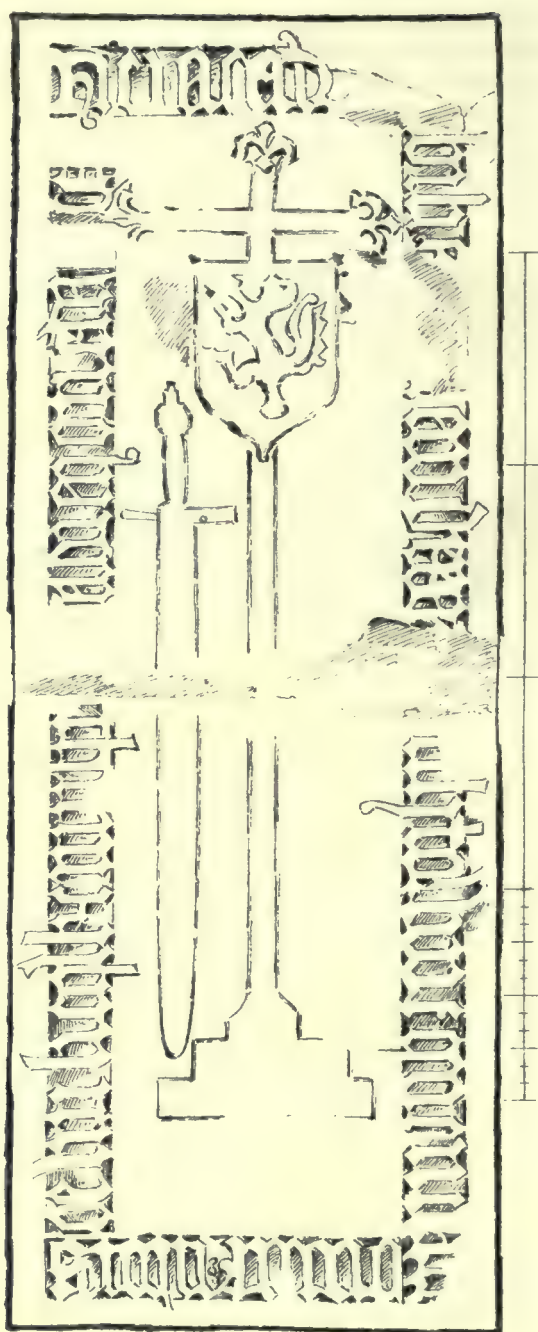
FIG. 439.—Bathgate Church. Slab in Church to Andreas Crichton.

The grave slab (Fig. 439) has lately been fixed into the south wall. Some time ago it was lying on the floor. It measures 6 feet 2 inches long by 2 feet 3 inches wide, and bears a beautifully lettered inscription to the memory of Andreas Crichton. In the centre of the slab there is a cross, with the Calvary steps, and beneath the cross limb a shield with the Crichton arms (a lion rampant), and on the dexter side a long sword.
